## CHAPTER 7: SUBWATERSHED RESTORATION STRATEGIES

### 7.1 Brambleton

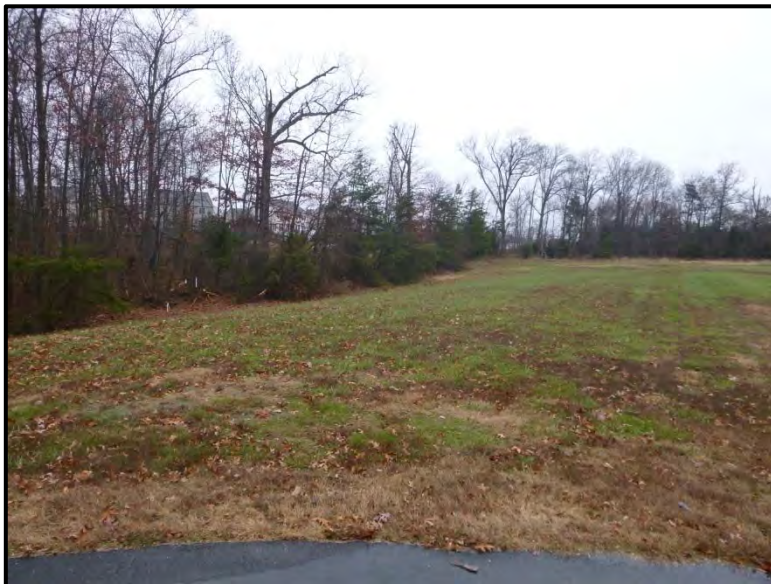
**Figure 7-4: Tree Planting Opportunity at NSA-21**

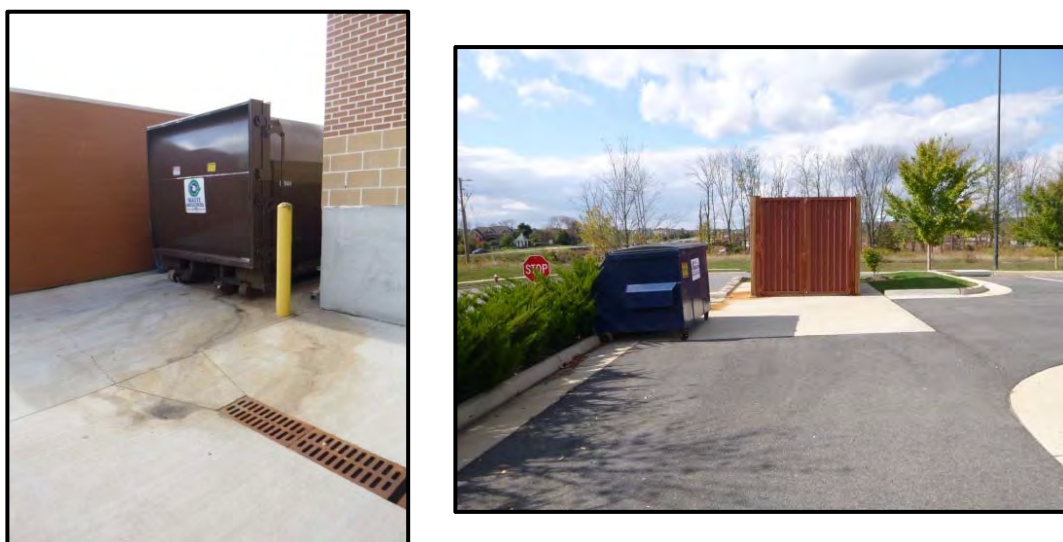
At the supermarket, signs of leakage into a storm drain inlet were found behind the building. Near the two-story miscellaneous business building, a dumpster was found near a storm drain inlet, though it was not leaking (Figure 7-5). The dumpster had been placed outside of the dumpster stall; neither area had secondary containment. For this site, a more judicious placement of the dumpsters away from the storm drain inlet, and adding secondary containment, would reduce the chances of direct input of pollution from dumpsters to the storm sewer system.

**Figure 7-5: Leaking Compactor (left) and Dumpster (right) Situated Near Storm Drain Inlets at HSI-001**

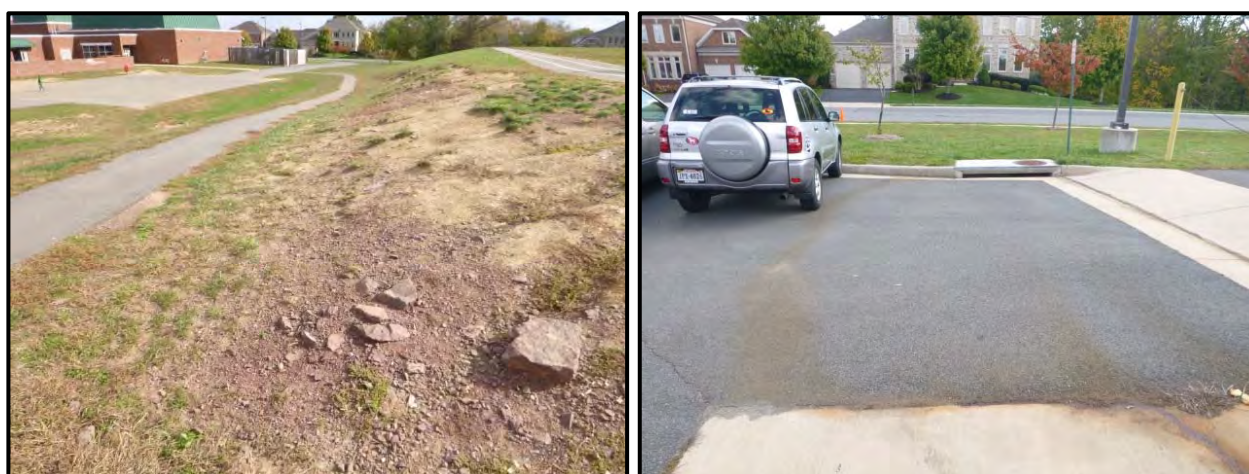
**Figure 7-6: Terracing Opportunity to Address Erosion (left) and Stains Leading from Dumpster to Storm Drain Inlet (right) at Legacy Elementary School**

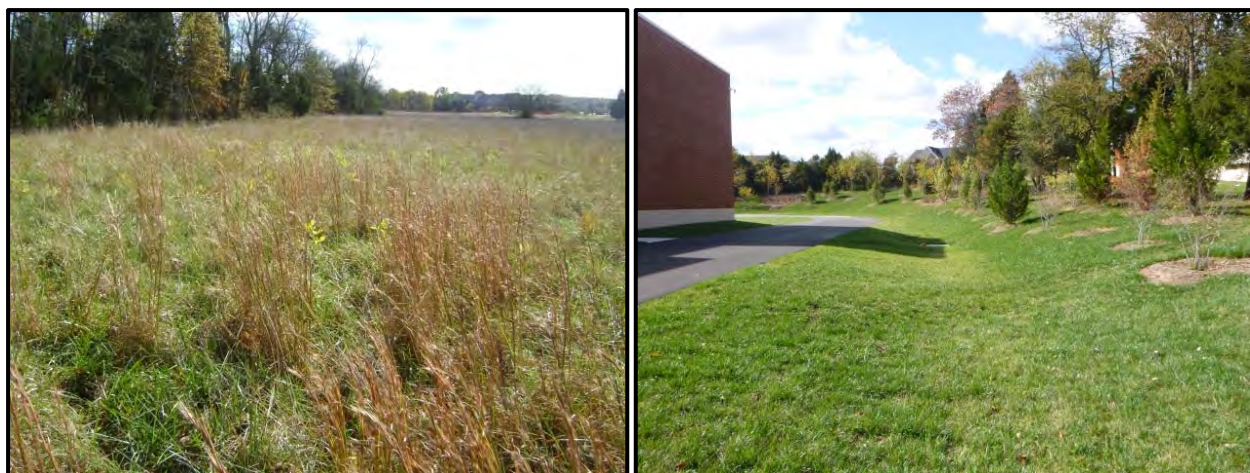
**Figure 7-7: Opportunities for Stream Buffer Augmentation (left) and Bioretention (right) at Moorefield Station Elementary School**

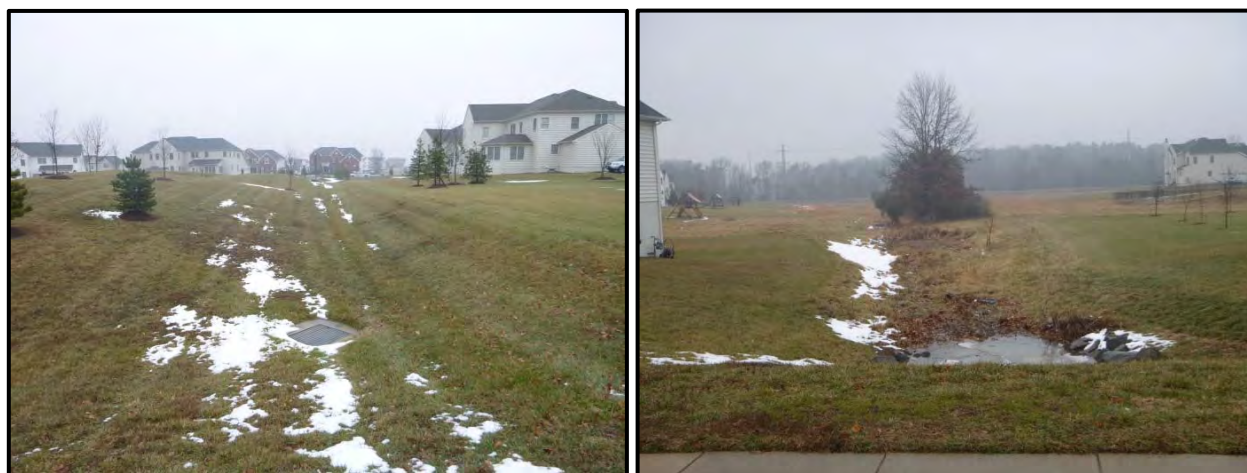
The neighborhood assessed within the Upper Broad Run Mainstem subwatershed had several opportunities for improvement. It was estimated that 50% of the downspouts within this neighborhood are directly or indirectly connected to the storm drain. The large portion of the neighborhood covered by mowed lawns provides a great opportunity for rain garden installation and conservation planting. Storm drain marking, which offers an opportunity to not only engage residents, but to serve as a visual reminder of the downstream effects of residents' actions, was also recommended for this neighborhood. A large amount of open space in common areas that is suitable for bioretention areas/rain gardens and tree planting was noted in several portions of the neighborhood (Figure 7-10). In addition, actions as simple as adjusting mowing practices and tree plantings along the ephemeral channel that carries stormwater offsite may help to slow down high flows that cause bank erosion and to intercept nutrients and toxins before they enter the aquatic ecosystem.

**Figure 7-10: Bioretention Opportunity (left) and Tree Planting Opportunity (right) Within NSA-10**

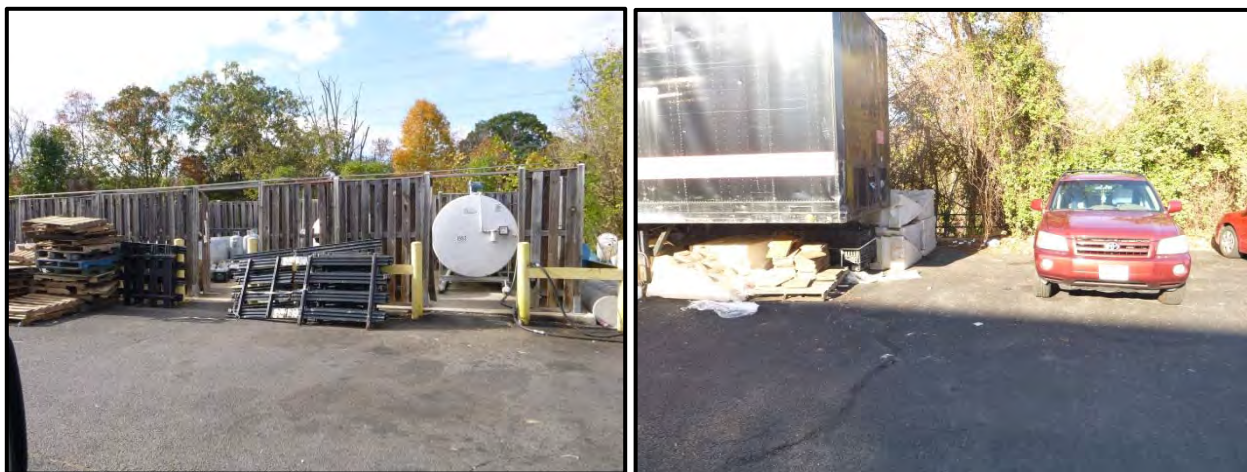
Evidence of vehicle maintenance activities was inferred from the presence of at least one truck with an open hood. Fleet fueling operations without the benefit of a canopy was therefore noted. Two dumpsters were found onsite with tops open and with noticeable trash accumulation along a tree line behind the rear parking and inventory storage area. Recommended improvements to the site include the addition of sheltering structures for the fueling area, waste management training for employees, and movement of truck maintenance activity indoors as not to be exposed to precipitation.

**Figure 7-11: Piled up Pallets and Uncovered Fueling Station (left) and Storage of Material Under Trailer (right) at HSI-002**

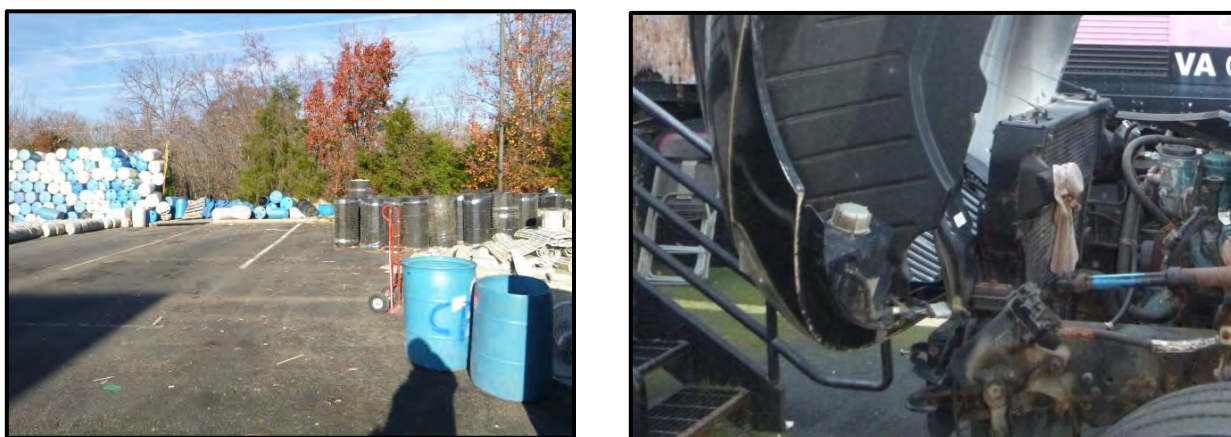
**Figure 7-12: Inventory Stored Outside, on Impervious Surface, near Storm Drain Inlet (left) and Vehicle Maintenance Activity (right) at HSI-002**

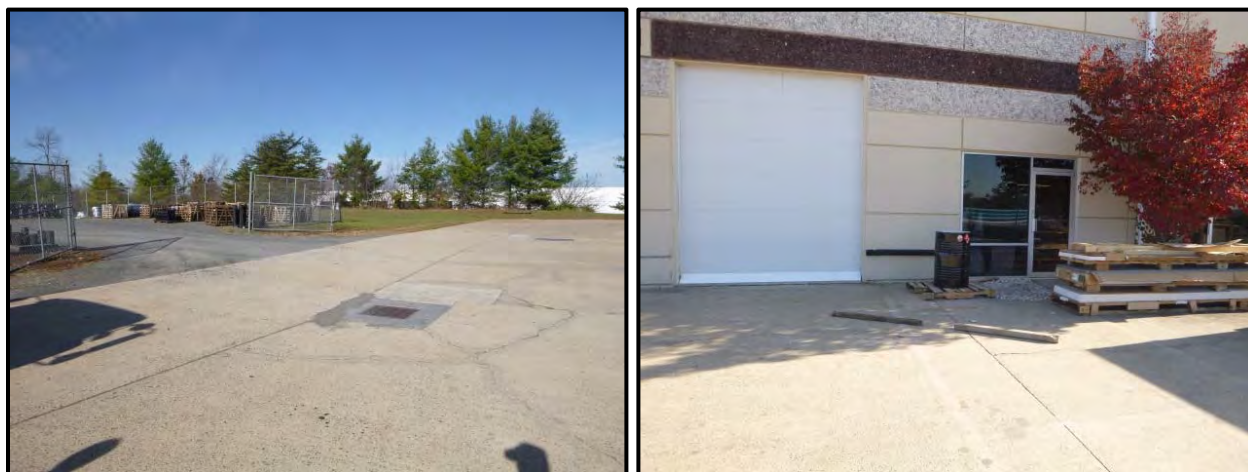
At another storm drain inlet, substantial gravel was found deposited near the opening, likely contributing to sediment transport to the storm drain system (Figure 7-13). The gravel appears to be tracked from a pervious storage yard, which contains inventory of cast iron, concrete, and plastic piping. In addition to the outside storage of inventory, one barrel of lacquer was noted in the rear parking lot, stored in the open. For this site, a sweeping plan is recommended to reduce tracking and transport of gravel material out of the yard and into the vicinity of the storm drain inlet. Secondary containment is recommended for liquid materials. Lastly, a network of canopies or hardened shelters is recommended to reduce the exposure of inventory items to precipitation.

**Figure 7-13: Storm Drain Inlet near Inventory Storage Area (left) and Outside Storage of Barrel of Lacquer (right) at HSI-003**

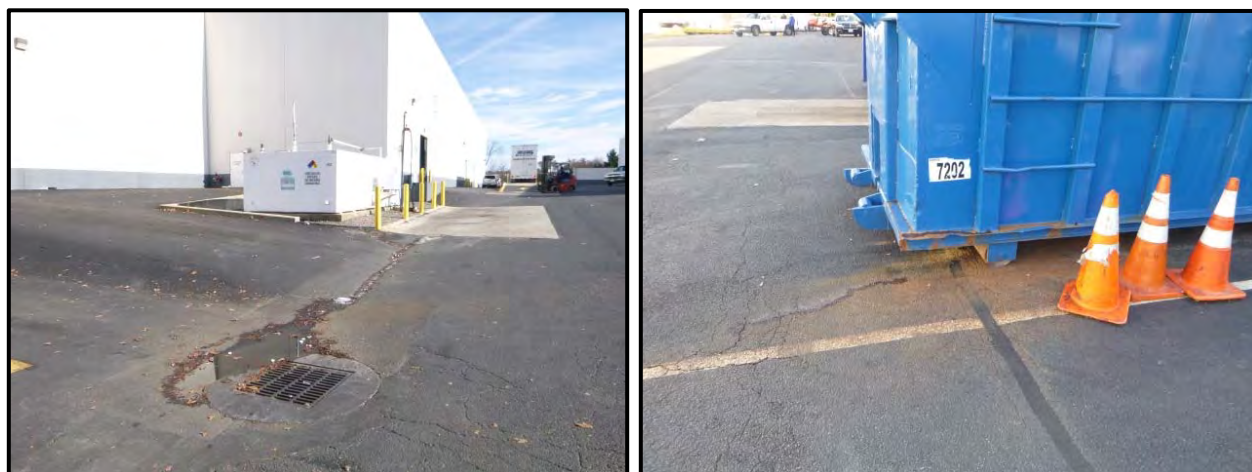
HSI-004 on Mercure Circle consists of two adjacent buildings. A large fueling station is situated between the buildings. The fuel tank appears to be double-walled to contain spills, but the overall fueling facility lacks a canopy that would reduce the risk of pollutants washing into a storm drain inlet during storms (Figure 7-14). A rollaway dumpster was noted on the site, which showed signs of leaking onto the impervious parking area between the buildings. Evidence of outdoor vehicle maintenance was also observed. Field staff also found a drum of liquid material resting on a pallet and a small number of bales of cardboard material stored outside. Given the facility's extensive building size, material could likely be stored inside and out of the reach of the erosive and leaching properties of rainfall. The pollution exposure profile could also benefit from modifying procedures to move servicing of vehicles indoors.

**Figure 7-14: Uncovered Fueling Station (left) and Rollaway Dumpster with Signs of Leakage (right) at HSI-004. Note that the liquid near the storm drain inlet (left) is melted snow.**

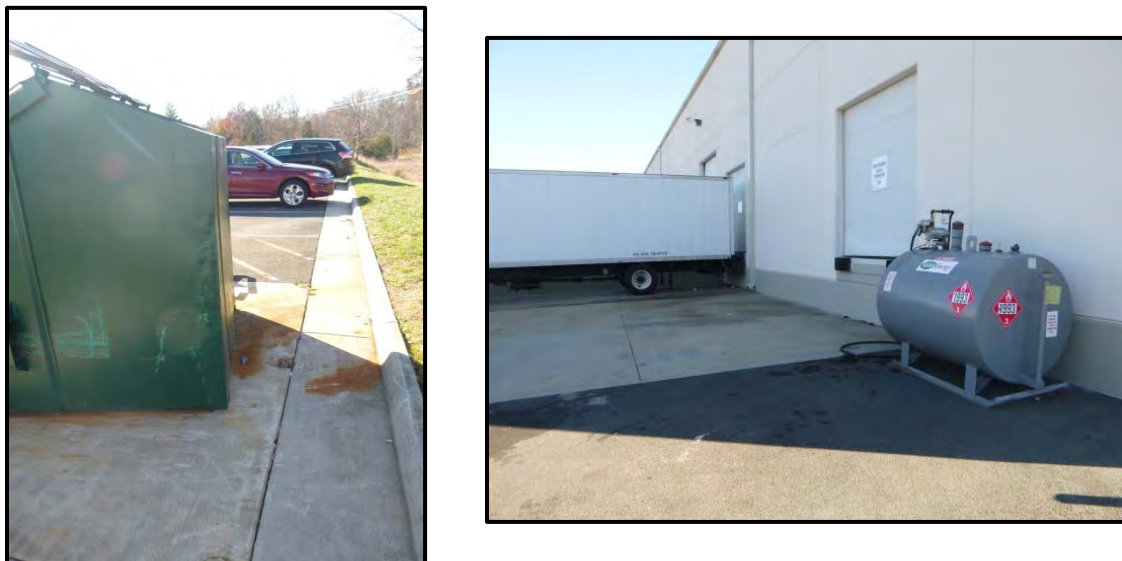
Multiple businesses are housed within HSI-007. A number of fleet vehicles were found onsite, along with a small fueling station. The fueling station, though small, lacked a canopy and would benefit from sequestration in a secondary containment area with proper sheltering (Figure 7-15). Also lacking protective awnings were the several loading docks noted onsite. A dumpster was found open and with evidence of past staining on the impervious surface. Employee training in the best practices of waste management would decrease the likelihood of transporting pollution to the stream network.

**Figure 7-15: Open Dumpster (left) with Signs of Staining and Uncovered Fueling Station (right) at HSI-007**

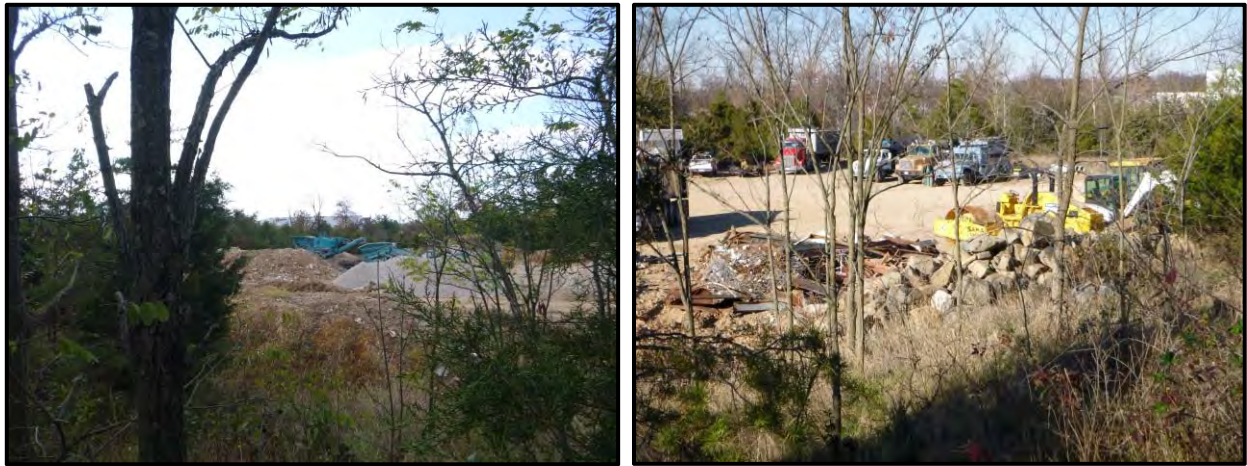
**Figure 7-16: Views of Gravel Piles (left) and Scrap Metal, Boulder Piles, and Construction Equipment at HSI-008**

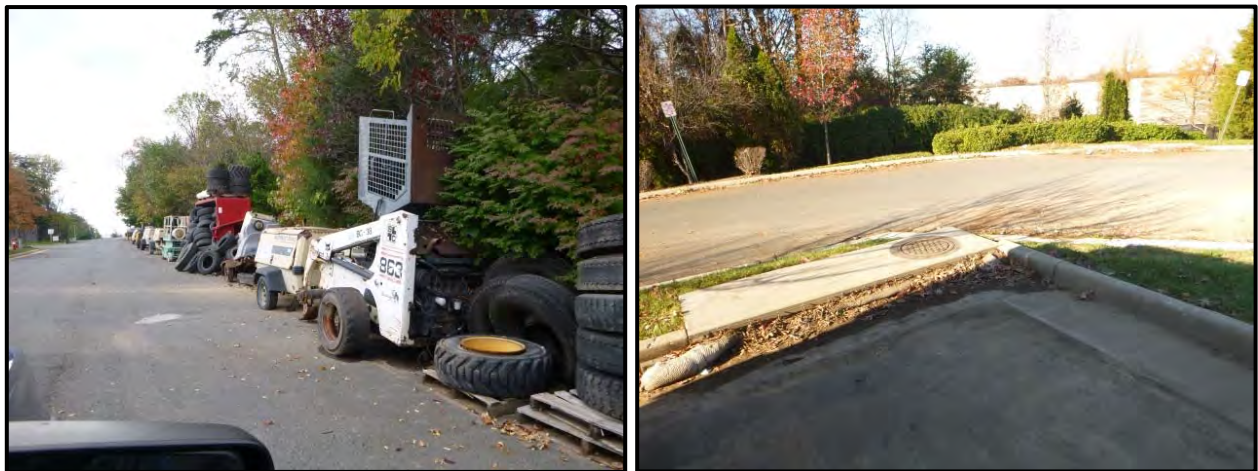
At HSI-009 on Mercure Circle, field staff identified a number of housekeeping problems in the rear lot. Storm drain inlets were found blocked by absorbent logs. In another area, bundles of used and broken up tire treads were found stacked along a gutter pan that led to a storm drain inlet (Figure 7-17). One bundle was found resting on top of a storm drain inlet (Figure 7-18). Junked or inoperable equipment was also found parked along the same gutter pan; a Bobcat had obvious oil staining underneath. Staff also identified a scrap metal pile on an impervious surface, a rollaway dumpster full of waste construction material, scrap metal bins and lumber and chain link fencing inventory stored in the open on impervious surfaces.

**Figure 7-17: Junked Equipment and Tires Awaiting Disposal on Impervious Surface (left) and Blocked Storm Drain Inlets (right) at HSI-009**

For inventory and equipment storage, especially on this impervious rear lot, canopies and shelters are recommended. Staff would also benefit from training on the proper storage of waste materials. Sediment and hydrocarbon runoff should be addressed with modifications to onsite procedures and not by relying on berms at storm drain inlet orifices. Increasing the frequency of inoperable equipment removal would also greatly benefit the site by removing pollution-causing materials from a direct route to storm drain inlets at this site.

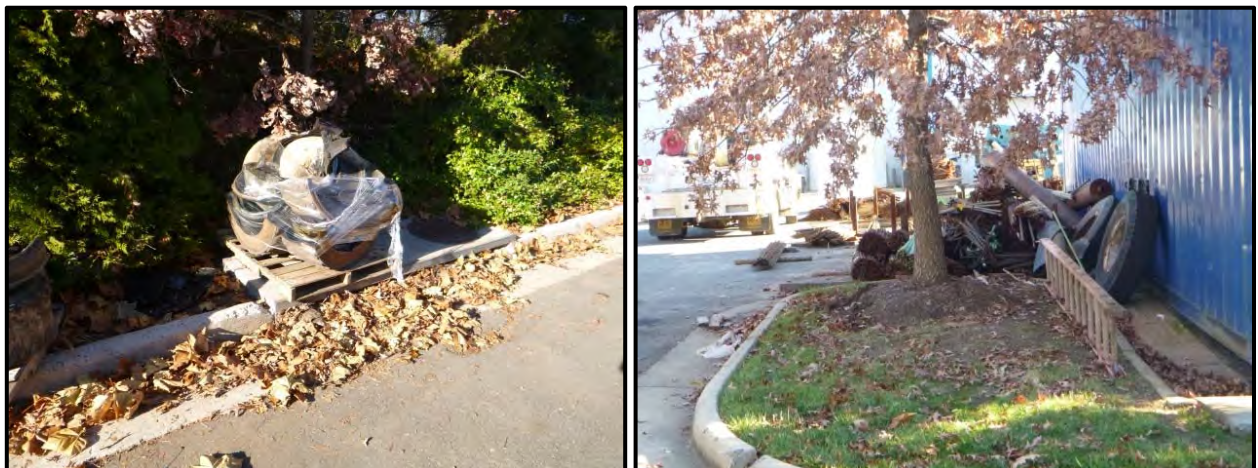
**Figure 7-18: Tire Bundle Resting on Storm Drain Inlet (left) and Scrap Metal Pile on Impervious Surface (right) at HSI-009**

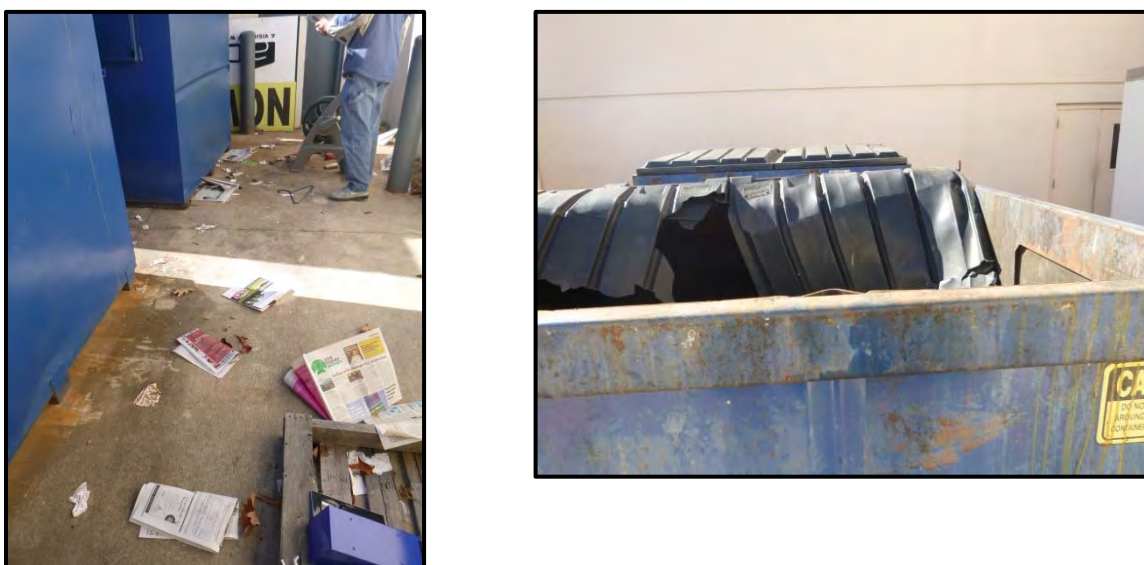
Two hotels comprising HSI-005 were evaluated for hotspot status. Both hotels and their environs were found in good condition as they appeared to be newly constructed. Staff found that the only potentially pollution-causing conditions were the areas around the dumpster stalls (Figure 7-19). The dumpster at one of the hotels was found with a collapsed lid and was open to the elements. The dumpster stall for the other hotel had noticeable papers and pieces of discarded material strewn about on the inside. The staffs at both of these hotels would contribute to watershed stewardship by modifying waste management procedures and increasing their and their guests' awareness of their actions on the subwatershed.

**Figure 7-19: Loose Trash (left) and Damaged Dumpster (right) in Dumpster Stalls at HSI-005**

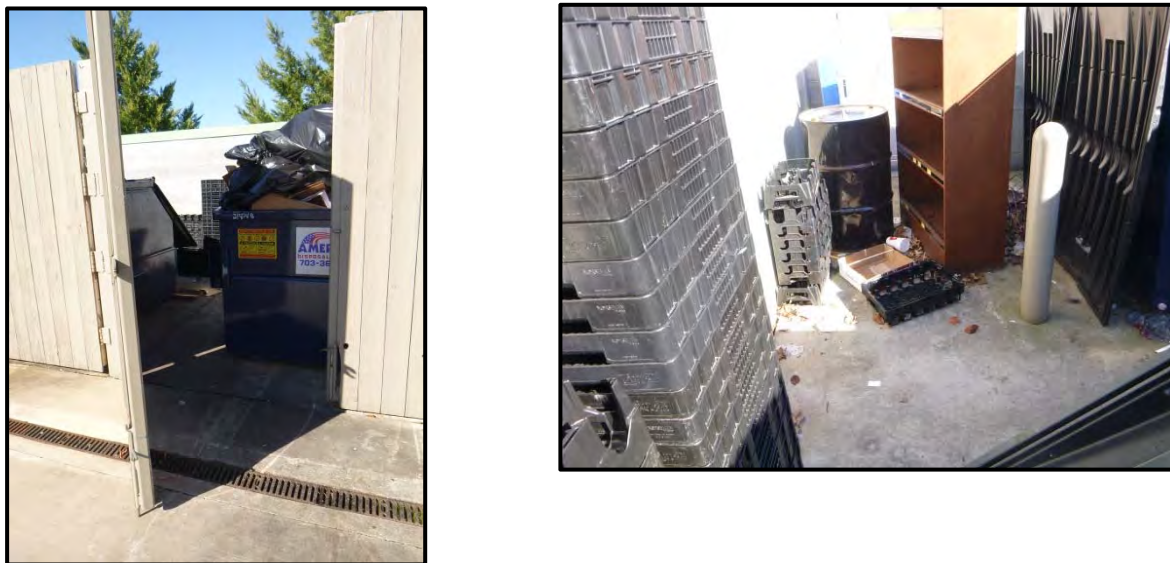
At a gas station and convenience store, Versar field staff identified waste management problems. Specifically, dumpsters in the designated stalls were found to be open or overflowing (Figure 7-20). Additionally, discarded bulk material, retail racks, a 55-gallon drum, and stacks of plastic product frames were found in the dumpster stall. All material was open to the elements which could potentially allow pollutants to be transported to a trench drain in close proximity to the stall. The trench storm drain immediately in front of the dumpsters was filled with enough material to allow grass to sprout. In a peripheral parking area near the gas pumps, staff found substantial staining of the asphalt, probably due to trucks and contractor vehicles visiting the convenience store. Versar recommends improvements in waste management procedures and training of staff so that accumulation of potentially pollution-causing material does not

**Figure 7-20: Overflowing Dumpster (left) and Storage of Bulk Material (right) in the Open at HSI-006**

accumulate or leach from the areas around the stalls. Maintenance on the trench drain would also remove another source of pollution to the stormwater network.

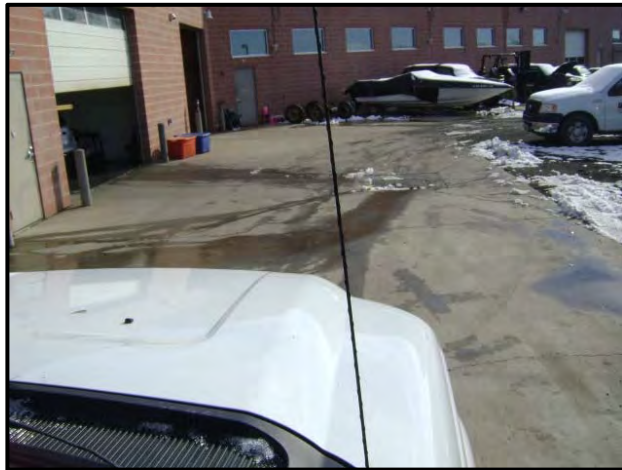
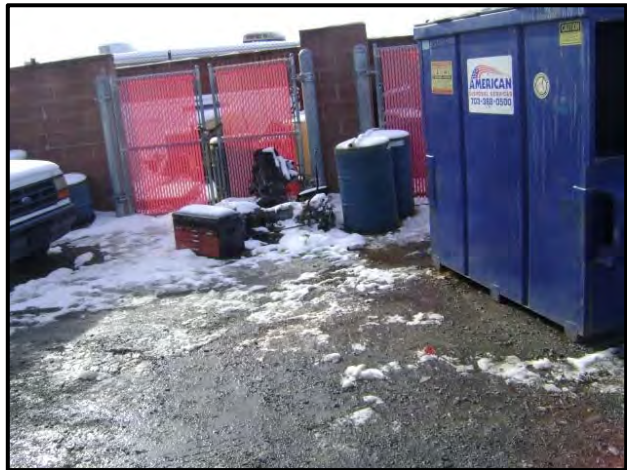
**Figure 7-21: Excess Water from Washing Flowing Toward Storm Drain Inlet (left) and Discarded Material Near Dumpsters (right) at HSI-016**

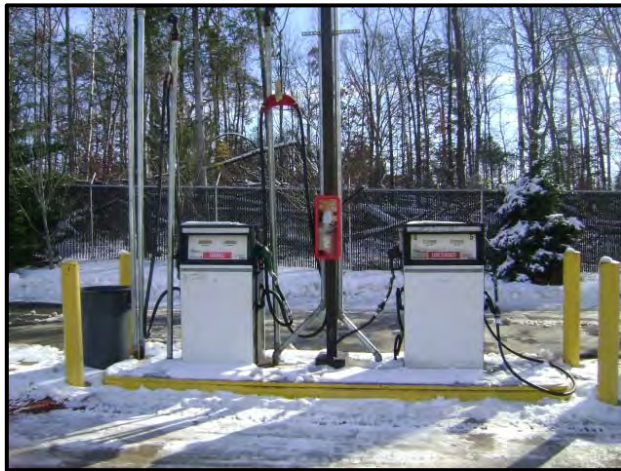
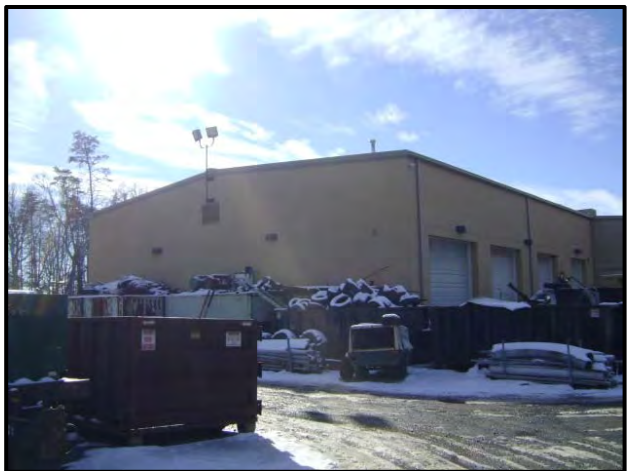
**Figure 7-22: Uncovered Fueling Station (left) and Outdoor Storage of Discarded Tires (right) at HSI-017**

The contribution by the business to polluted runoff could be reduced by placing material and conducting activities under canopy covers or shelters. Bulk waste, such as the bins of tires, should be removed quickly so that metals such as zinc are not accumulated and washed to the storm drain system. Bulk material, such as dirt, should be protected from the elements by using, at the very least, tarps. Training of employees, along with modification of waste management, equipment repair, and fueling procedures, would go a long way toward reducing this business' contribution of pollutant and sediment load to local streams.

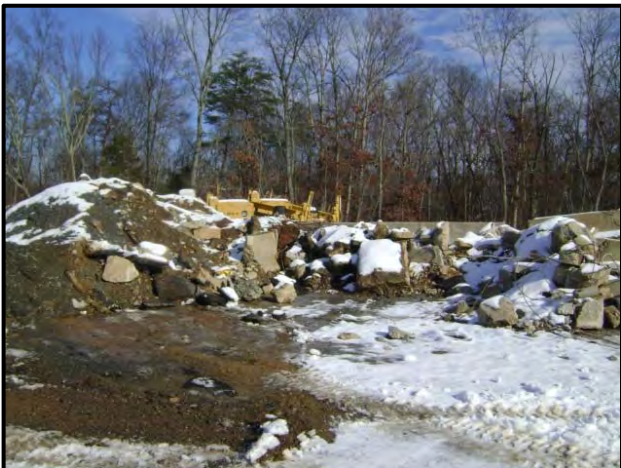
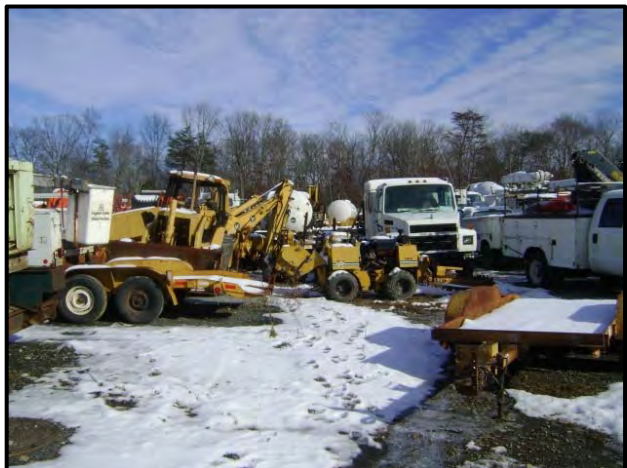
**Figure 7-23: Uncovered Piles of Dirt and Rubble (left) and Uncovered Equipment Storage Yard (right) at HSI-017**

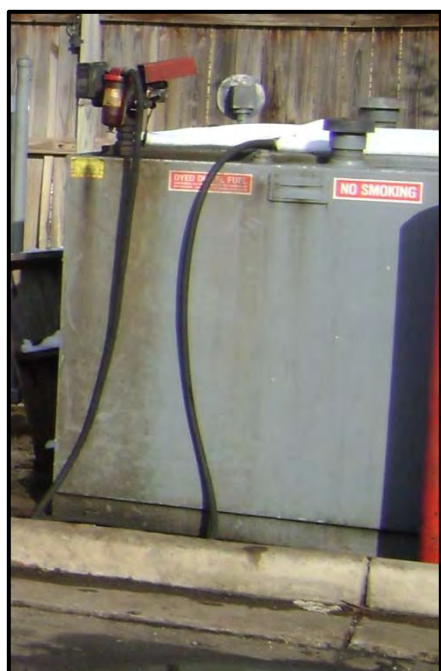
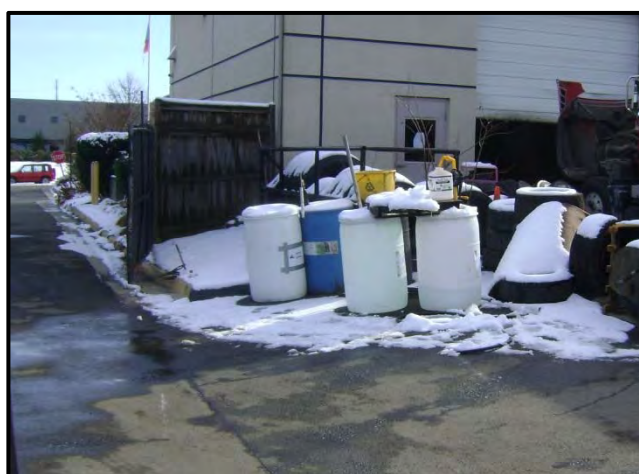
Nearby, a construction company manages a large fleet, has outside fueling stations, stores liquid material outdoors without secondary containment, and places quantities of inventory and bulk material (dirt) on impervious surfaces, thus increasing the likelihood of polluted runoff entering the storm drain system. A rollaway dumpster was also found on the site. Field investigators found evidence of outside vehicle repair. Used tires and other discarded material were found stored outside in the open (Figure 7-24). Centralized areas where discarded material is collected should, at the very least, be underneath a canopy cover or placed into a warehouse. Liquid material should have secondary containment. Improvements to site operations should also include placing a canopy cover over outdoor fueling areas and conducting vehicle repair indoors or under an appropriate sheltering system. Lastly, staff should update their training of waste management procedures, so that excess material does not concentrate onsite where it can be transferred to streams.

**Figure 7-24: Outside Fueling Station and Outside Storage of Inventory (left); and Outside Vehicle Repair, Outside Liquid Material Storage, and Discarded Tires (right) at HSI-018**

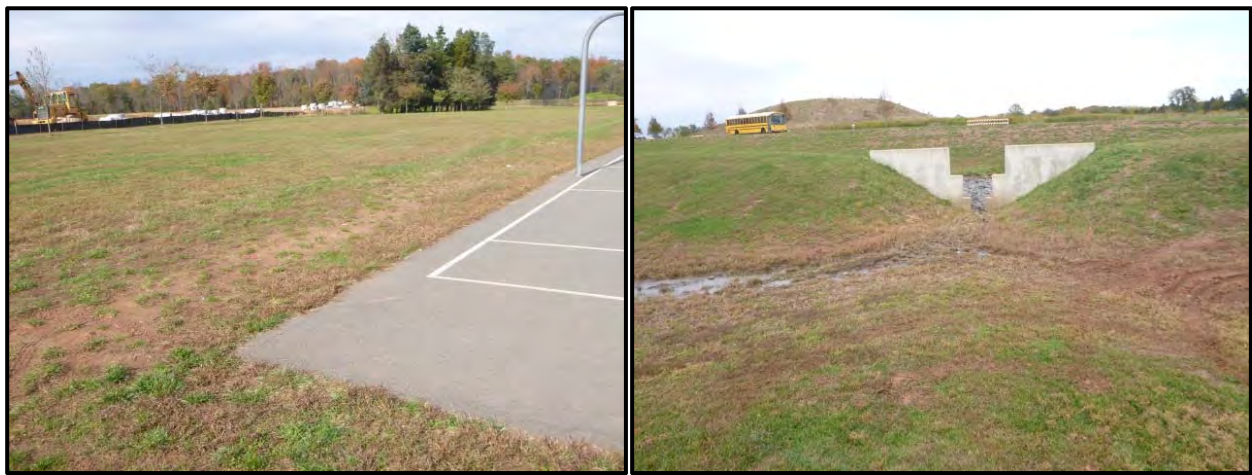
**Figure 7-25: Tree Planting (left) and Dry Pond Conversion (right) Opportunities at Stone Hill Middle School**

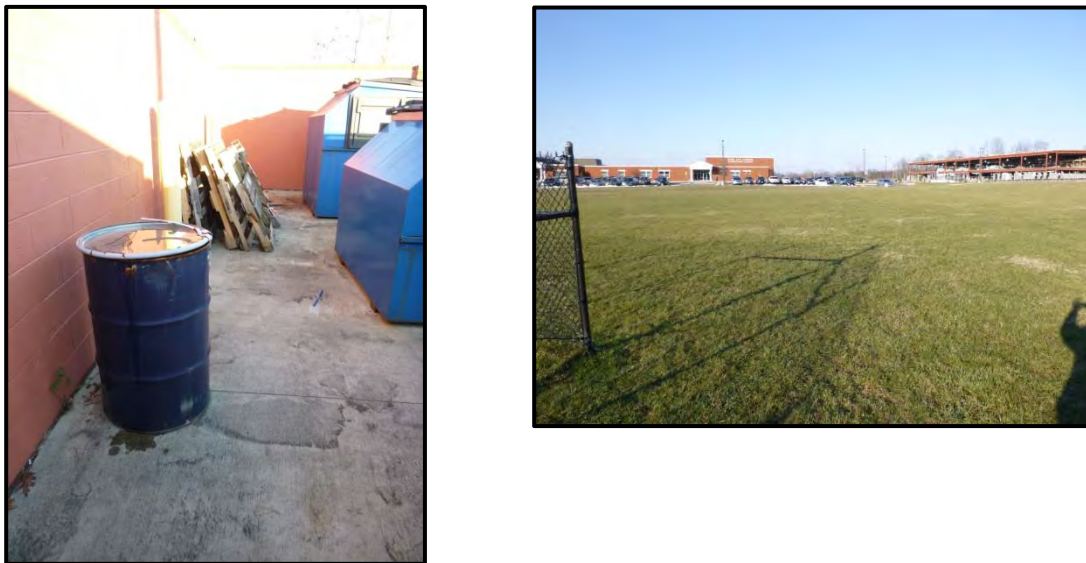
At Rosa Lee Carter Elementary School, a large expanse of grass was found immediately in front of the school building and adjacent to Loudoun Reserve Drive (Figure 7-26). The grassy area provides an excellent opportunity for reforestation. A drainage swale that runs through the grassy zone could be converted to bioretention to provide an extra measure of stormwater treatment and

**Figure 7-26: Waste Management Issue (left) and Tree Planting Opportunity at Rosa Lee Carter Elementary School**

infiltration. A tree planting, outreach, and education effort could be undertaken to restore the buffer along Broad Run, which forms the western border of the school. Approximately 300 feet of buffer has been eliminated due to sanitary sewer line construction; areas outside of the sanitary sewer line easement can be planted. Other areas near ballfields could also be planted with trees to extend the buffer. Waste management could also be improved through staff training. On the east side of the school, a dumpster was found to be leaking contents onto the impervious surface in near proximity to a storm drain inlet. Additionally, a waste cooking oil drum was found loosely capped and with rain water ponding on the lid. Implementation of restoration measures such as these will decrease the local stream's exposure to increased volumes of polluted stormwater effluent from the school and will establish the school as a positive example of environmental stewardship.

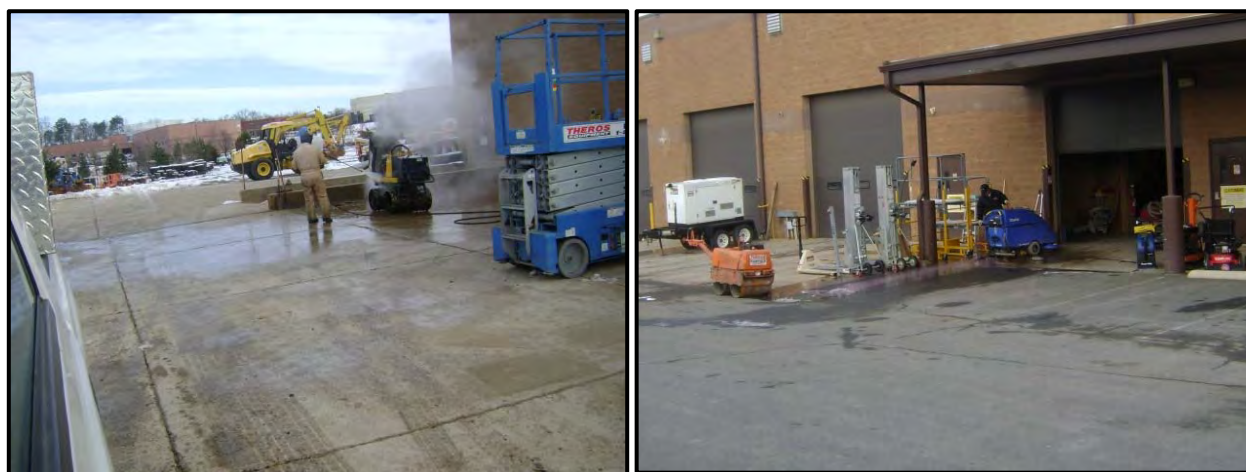
Upon arrival at HSI-014, Versar investigators immediately noted an employee power washing equipment in an impervious area behind the building (Figure 7-29). After documenting conditions elsewhere on the business property, field staff returned to the loading dock area to find an employee dumping floor cleaning machine contents into a storm drain inlet. The activity would potentially be considered an illicit discharge; therefore, County staff were promptly notified. In addition, staff identified a number of potential pollution causing practices onsite. The company stores, maintains, and repairs its equipment and vehicles outside. Additionally, an outdoor fueling station is present and was found not to have a canopy cover (Figure 7-30). Vehicle parts and a pile of gravel were found outdoors. Beneficial actions for HSI-014 include instructing employees on the proper disposal of material to avoid illicit discharges. The site can be retrofit so that any equipment washing required takes place indoors and the effluent directed to a sanitary sewer. Inventory, parts, and equipment stored outside, as well as the fueling station, should be sheltered to decrease the likelihood of pollutants washing onto impervious surfaces and being transported to the storm drain system.

**Figure 7-29: Power Washing of Equipment Outside (left) and Dumping of Floor Cleaner Contents into a Storm Drain Inlet (right) at HSI-014**

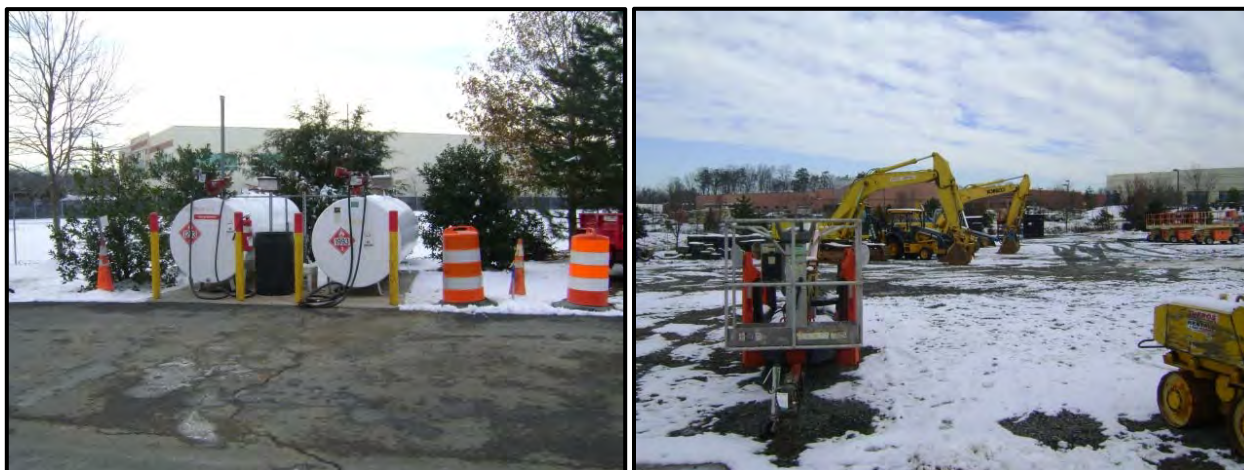
**Figure 7-30: Uncovered Fueling Station (left) and Uncovered Equipment Storage Yard (right) at HSI-014**

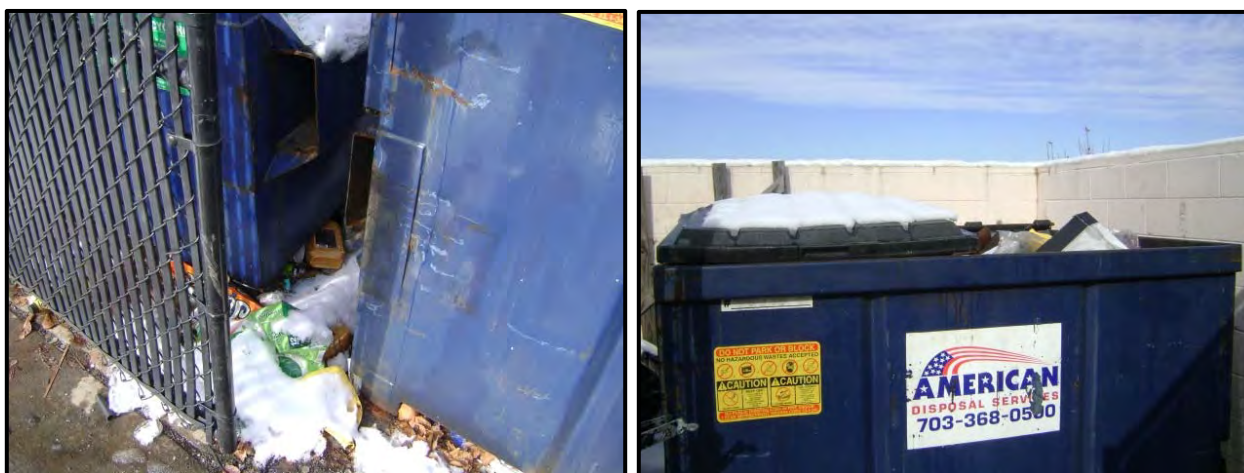
HSI-015 includes three transportation maintenance businesses. On the site, Versar field staff found open, overflowing dumpsters (Figure 7-31). Field staff also noted fleet vehicles likely belonging to one of the companies. To reduce pollution problems, fleet vehicles should be stored under canopy cover and if repair is required, the service should be performed indoors. To reduce the possibility of blowing trash leaving the site and being washed into a storm drain, and to reduce the possibility of dumpster leachate doing the same, employees should be trained in proper waste management techniques.

**Figure 7-31: Loose Trash (left) and Open Dumpster (right) at HSI-015**

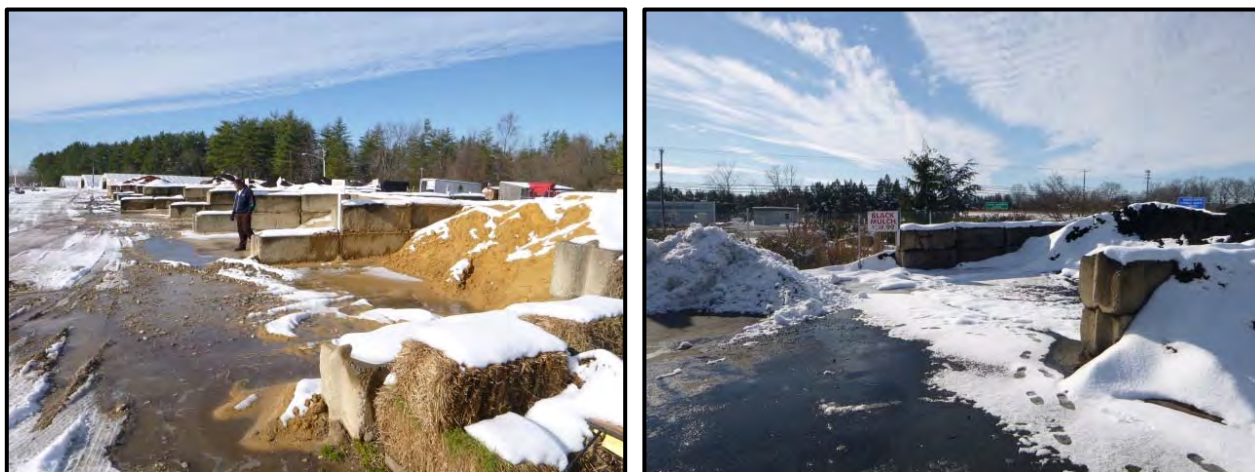
**Figure 7-32: Uncovered Inventory Stalls on Pervious Surface (left) and a Portion of Impervious Surface (right) Near an Inlet to a Stormwater Ditch (background right) at HSI-012**

Bulk materials such as these that could easily suspend and wash into waterways during heavy downpours would benefit from canopy cover.

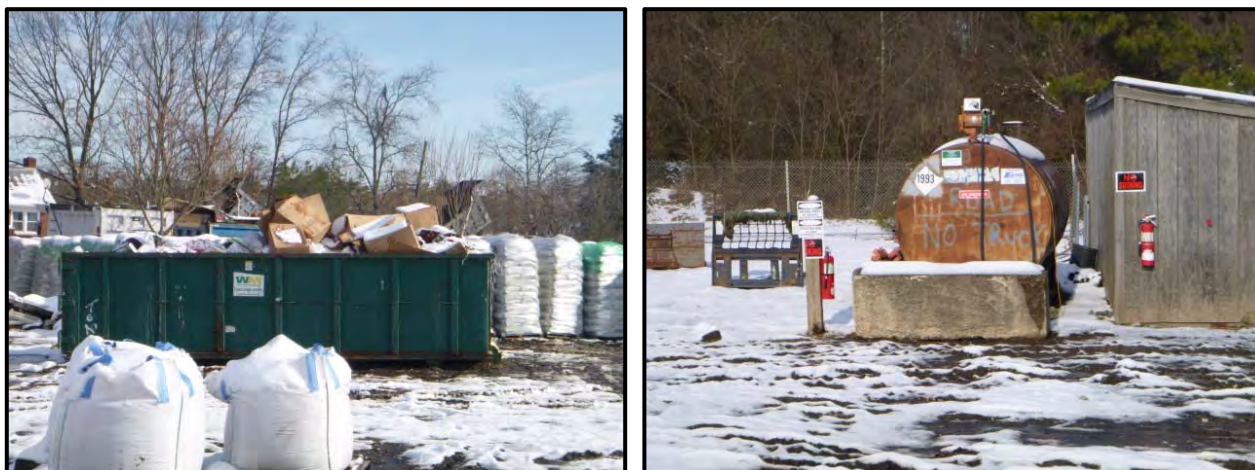
Elsewhere on the property, field teams found large tanks that at one time had contained fuel, according to an employee. At least one other tank appeared to be still in use for fueling purposes, though without a canopy cover. A canopy cover over the fueling station would reduce the possibility of pollutants and hydrocarbons being transported to waters of Dulles subwatershed. The station would also benefit from secondary containment to keep spills localized in the first place. Investigators found and documented collections of discarded material (e.g., pallets), an overflowing rollaway dumpster (Figure 7-33), garden center supplies (e.g., pots), and inventory (e.g., boulders on pallets), all of which were stored outside without canopy cover, though mostly on pervious surfaces. Employee training and placement of material under canopies would help improve the quality of stormwater runoff leaving the site.

**Figure 7-33: Overflowing Rollaway Dumpster (left) and Uncovered Fueling Station (right) at HSI-012**

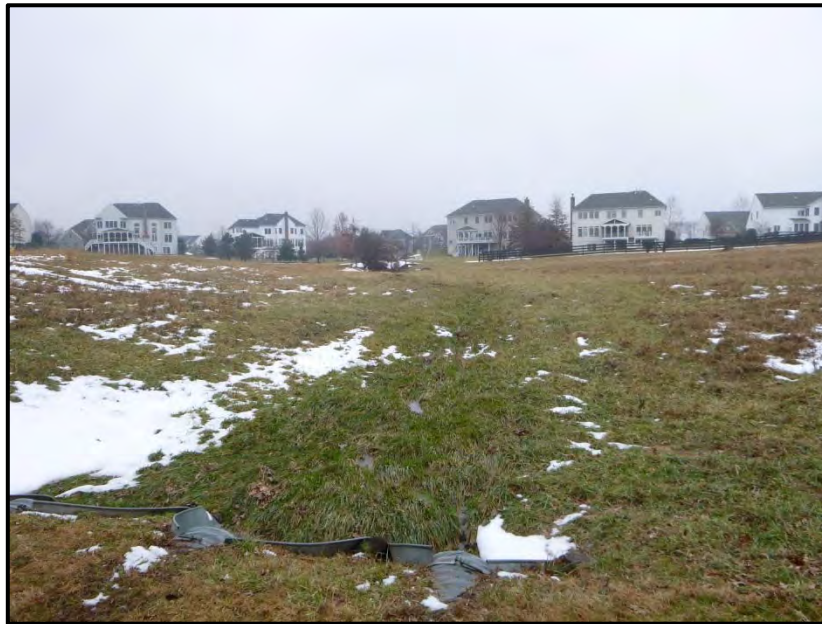
**Figure 7-36: Grassy Field that Conveys Stormwater Runoff from Impervious Surfaces within NSA-9 to the Local Stream**

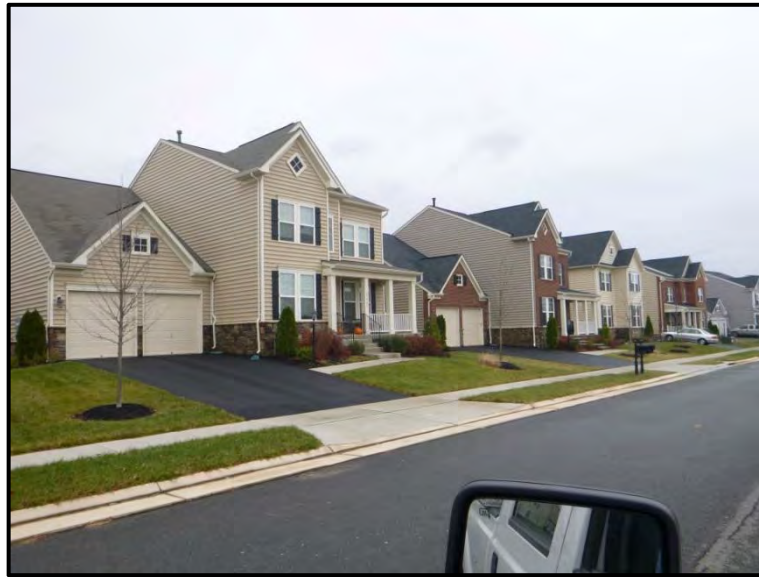
**Figure 7-39: Typical Downspouts and Front Yards in NSA-5 with an Opportunity to Redirect Downspouts to Pervious Area**

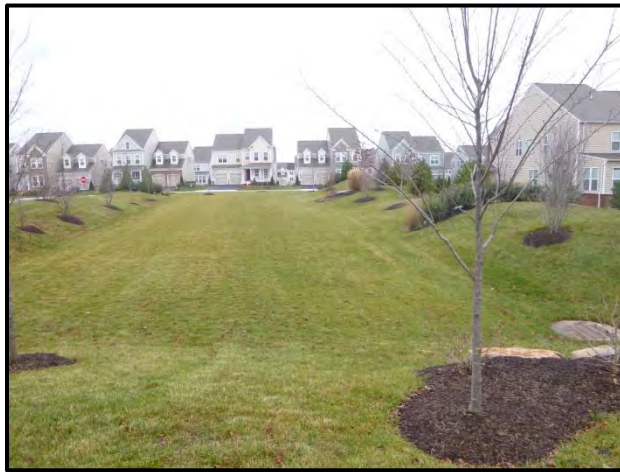
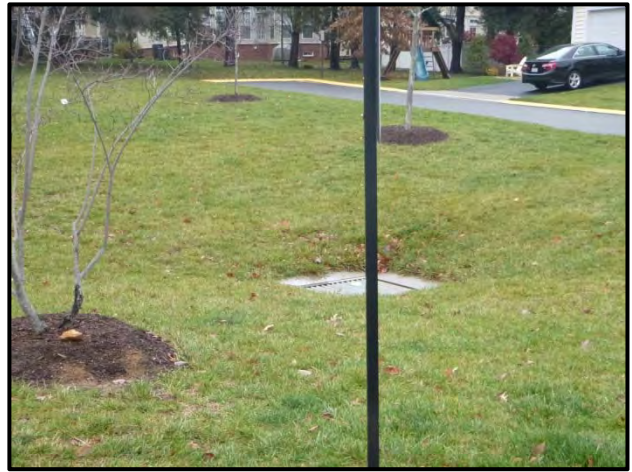
**Figure 7-40: Rain Garden Installation Opportunity in NSA-5 (left) and NSA-4B (right)**

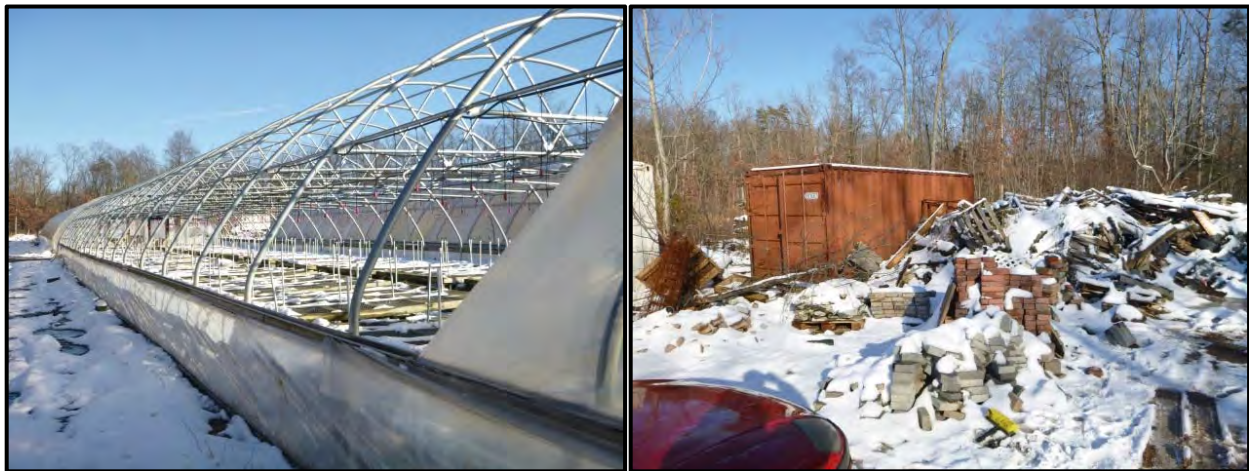
**Figure 7-41: Greenhouse with Missing Roof (left) and Pile of Building Materials (right) at HSI-013.**

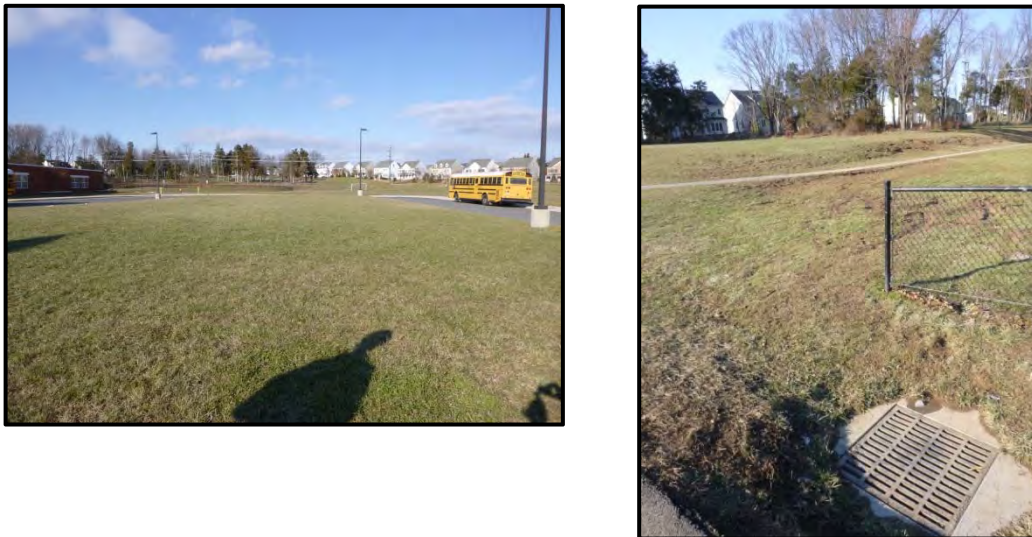
**Figure 7-42: Tree Planting Opportunity in Bus Turnaround Area (left) and Bioretention Opportunity (right) at Creighton's Corner Elementary School**
